# A Study on the Mechanism of Abnormal Combustion Caused by Abnormal Electrical Discharge in a Direct-Injection Hydrogen Engine for Motorcycles

*1) Kawasaki Motors, Ltd.*

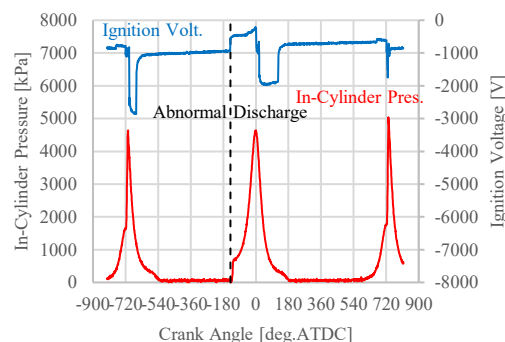
Fig.2 Ignition secondary voltage measurements

Simultaneous measurements of ignition secondary voltage showed a sudden drop in residual voltage just before pre-ignition (Fig.2). The results indicate that residual electrical energy remaining in the secondary side of the ignition system after hydrogen combustion caused unintended discharge, which subsequently triggered pre-ignition.

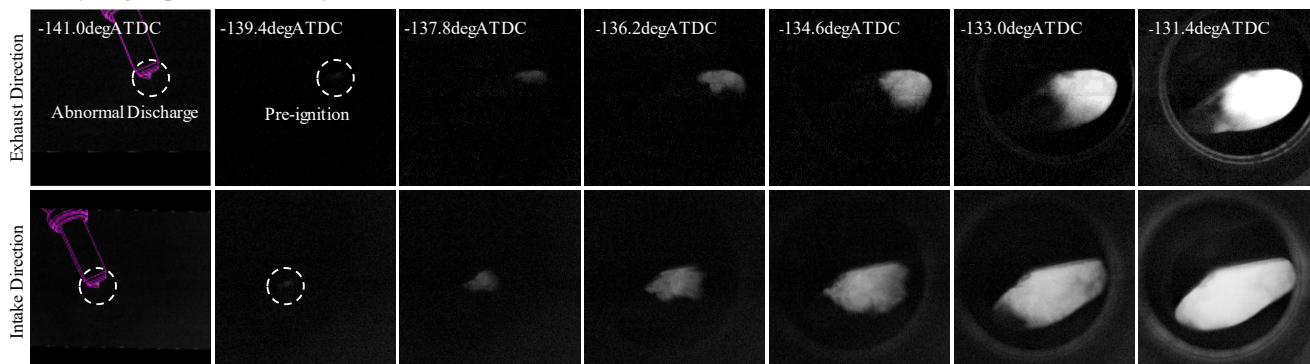
Fig.1 In-cylinder abnormal combustion visualization by simultaneous dual-direction direct imaging

Experiments were performed at 2000 min<sup>-1</sup>,  $\lambda = 1.0$ , and advanced fuel injection timing (EOI = -180deg.ATDC). High-speed imaging revealed that pre-ignition originated near the spark plug and propagated throughout the combustion chamber. A brief light emission observed at the spark gap immediately before pre-ignition suggested the occurrence of abnormal discharge (Fig.1).
