# Considerations and Countermeasures for Reliability Design of BGA Solder Joints.

Hisao Nishimori<sup>1)</sup> Jun Muto<sup>1)</sup> Yasufumi Shibata<sup>1)</sup>

*1) Toyota Motor Corporation  
1, Toyota-cho, Toyota, Aichi, 471-8572 Japan*

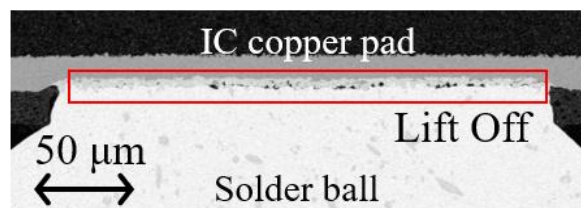
Cross sectional analysis of a functionally defective BGA package revealed a very thin lift-off region near the alloy interface between the copper pad on interposer board and the solder ball. To evaluate the occurrence and characteristics of this defect, three different BGA package ICs were analyzed using an ink penetration and pull method. After immersion in dye, drying, and separation from the printed circuit board, fracture surfaces were classified into five fracture modes designated A through E. The observed defect corresponded to Mode B fracture, which occurred in approximately 2 – 7 % of the evaluated solder joints. Detailed observation of the peeled surfaces revealed dye penetration on fracture interfaces where no dye should have been present in a sound solder joint, suggesting the existence of localized interfacial separation prior to fracture. X-ray inspection was subsequently conducted to assess the detectability of the defect by non-destructive means. Although X-ray images successfully identified voids and wiring structures, no obvious indication of the thin interfacial lift-off could be detected, even in samples later confirmed to contain Mode B failures through destructive analysis. These findings indicate that conventional inline X-ray inspection alone may not be sufficient to identify very thin delamination like defects in BGA solder joints. As automotive electronics continue to become more complex, reliability assurance must rely not only on manufacturing inspections but also on a design oriented understanding of potential failure mechanisms. Analysis of occurrence trends showed that larger BGA packages, particularly those with hundreds of solder balls, may exhibit a tendency for failure concentration near peripheral ball locations where warpage-induced stress is generally higher. Consequently, package warpage, local stress concentration, PCB structural design, and via configuration should be considered carefully during reliability design reviews.

Fig.1 Cross section photo of BGA joint malfunction.

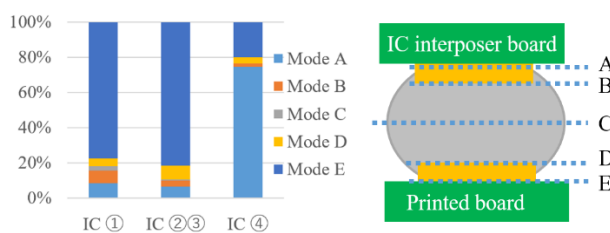
Fig.2 Definition of destruction mode of the peeled analysis (right) and graphs of the destruction mode occurrence rates at each ICs (left).

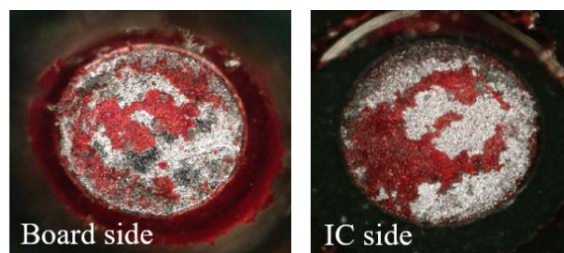
Fig.3 Results of the peeled surface observation which are the board side (left) and the IC side (right).
